Manhole Inspection Summary

Manhole # S11KK1004MH

Insp Date: **11/14/08 11:01 AM**

Location Address: **4548 PIMLICO RD**

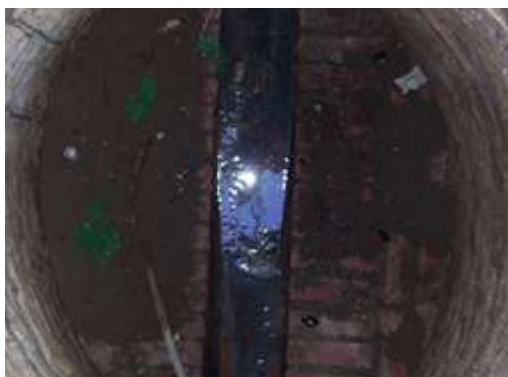
Defect 3

Surcharge ☒ **Evidence Of Surcharge** Depth: **1** (ft.) ☐ Active Surcharge Present

EVIDENCE OF SURCHARGE

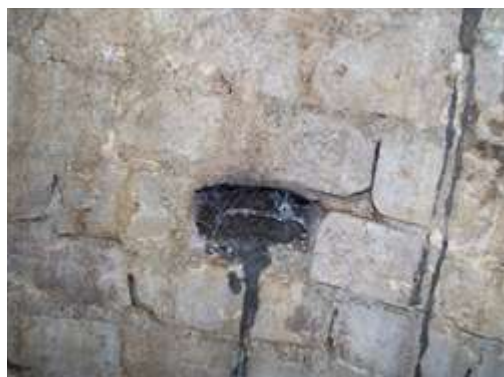
Defect 2

BRICK MISSING WHERE STEPS WERE PRESENT AT ONE TIME.

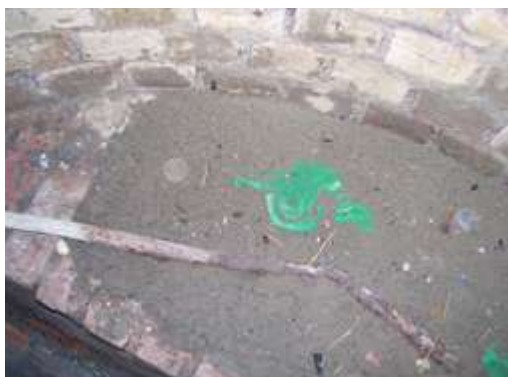
Defect 1

Condition: ☐ Sound ☐ Cracked ☐ Root Intrusion ☐ Deteriorated ☐ Leaks ☒ **Debris**

DEBRIS IN CHANNEL

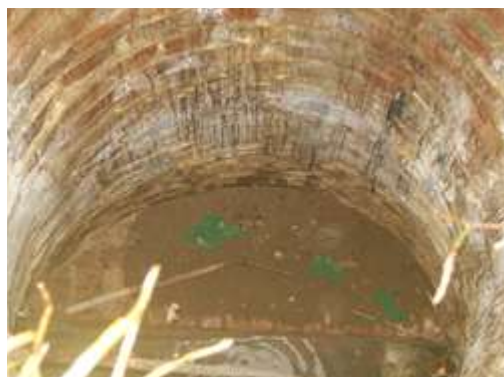
Defect 5

Infiltration: ☐ None ☐ Joint ☐ Cracks ☐ Mortar ☐ Roots ☒ **Wall**

barrel infiltration

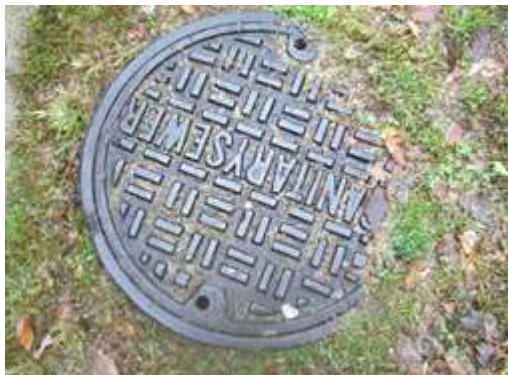
Defect 4

Type: **Sanitary** Condition: **Worn** Cover Material: **Cast Iron**

worn cover

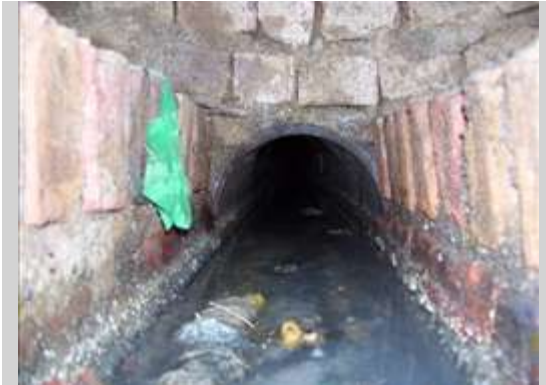
12 O'Clock Outflow

Deposits: ☐ None ☐ Mud ☒ **Sludge** ☐ Debris ☐ Grease

Silt Depth: **1** (in.) Deposits Extent: **Light**

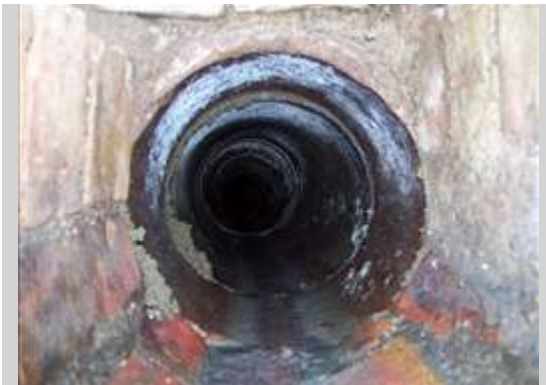
6 O'Clock Inflow

Deposits: ☐ None ☐ Mud ☒ **Sludge** ☐ Debris ☐ Grease

Silt Depth: **0.5** (in.) Deposits Extent: **Light**
